Weekly Construction Report Hatchery Creek Design/Build Project

Time Period: November 9-14, 2015		Project No:	1305
Rain Days/Weather Conditions:		Monday (Burkesville gauge) w for culvert on Monday.	hich limited working to
Personnel on-site:	EcoGro/Ridgewater: Tom Cutter, Eric Dawalt, Jim Hanssen, Larry		
	Mounce, Brad Redmon, Chad Relinski, Randall "Mokie" Starns,		
		Jr., Sherri Arthur Trucking-Jol	
Equipment on-site:	Komatsu PC 360 excavator w/ hyd. thumb, Komatsu PC 160 w/ hyd.		
		PC 210 excavator, Komatsu	
		culated off-road dump truck, E) track dump truck. Sheepsfo	
	mobilized to site	•	oot compactor was
Material deliveries to project		s of #8 stone for culvert beddi	ng and backfill delivered
site:	by Benny Brown.		
		of #57 stone for sidewalk sub	grade delivered by
	Benny E		
		d, rebar, etc. for forming sidew	
		c yards of Class A, 5% air enti k delivered by Albany Ready I	
Work performed the past		at and reach upstream of Car	
week:		to 118+40:	npground Road/ "Ota.

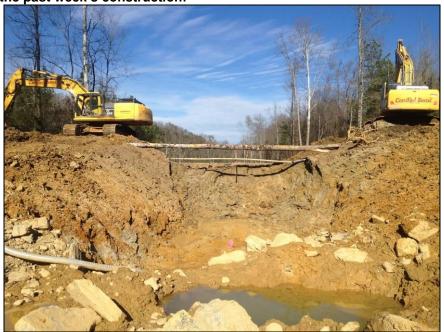
Excavating for culvert under Campground Road. Conduit for electric line is being suspended by log. (Picture taken looking downstream towards Campground Road).

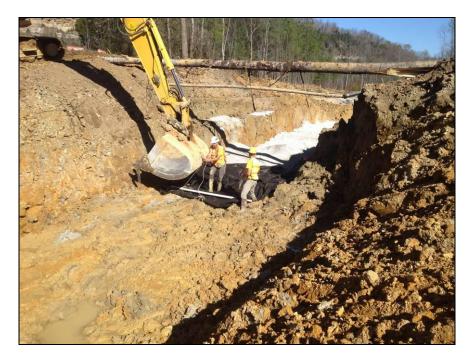
Installing geotextile over soft soil prior to installing gravel bedding for culvert. (Picture taken looking downstream towards Campground Road from Right Descending Bank (RDB)).

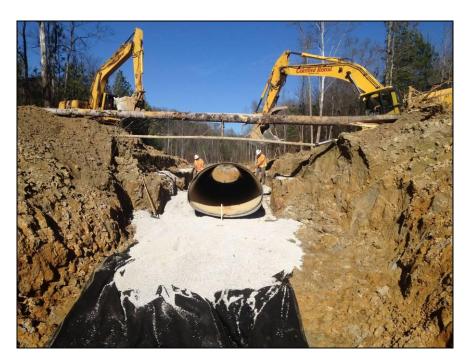
Backfilling sides of culvert with gravel and compacting it in lifts. (Picture taken looking downstream towards Campground Road).

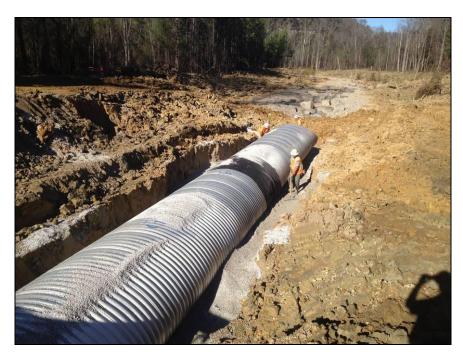
Backfilling sides of culvert with gravel and compacting it in lifts. (Picture taken looking downstream towards Campground Road from RDB).

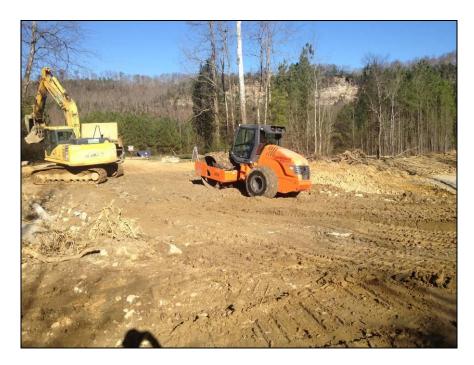
Installing shot rock as road fill over culvert and compacting it in lifts with a sheepsfoot compactor. Log suspending the electric conduit can be seen in left of picture. (Picture taken looking from RDB across Campground Road).

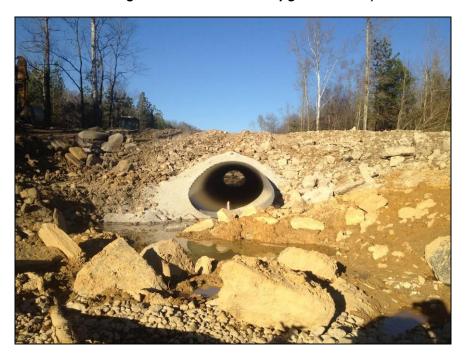
Completed culvert with gravel bedding and backfill completely around pipe, and road fill constructed of compacted shot rock. (Picture taken looking downstream towards Campground Road).

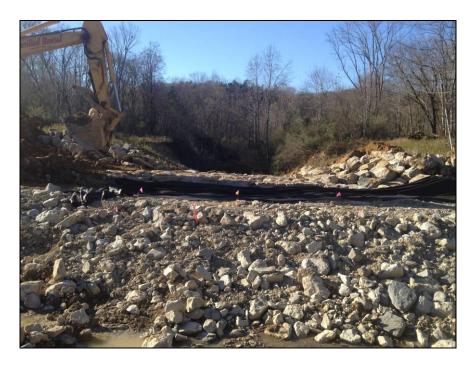
Ravine Spillway: Installing geotextile and shot rock between ravine spillway constructed of 24" diameter boulders (in background) and stream channel (in foreground). (Picture taken from RDB at ~Sta. 106+30 of stream channel looking towards LDB and down ravine spillway centerline).

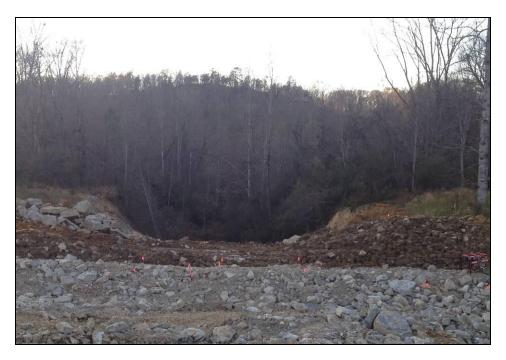
Ravine Spillway: Shot rock has been installed over 24" diameter boulders on right side of spillway. (Picture taken from approximate same location as above).

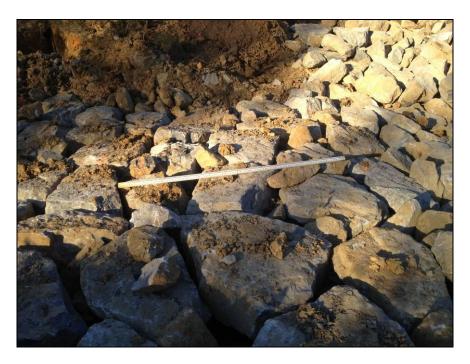
Ravine Spillway: The majority of the boulders in the ravine spillway are 24" or larger in diameter. The voids between boulders were later filled with shot rock. (Survey rod in picture is 8 feet long).

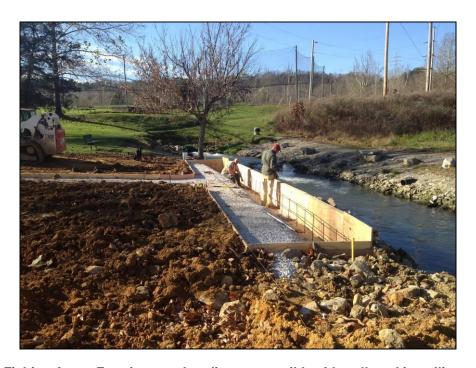
Public Fishing Area: Forming new handicap accessible sidewalk and installing rebar for structural support. (Picture taken from RDB at ~Sta. 103+00 looking upstream).

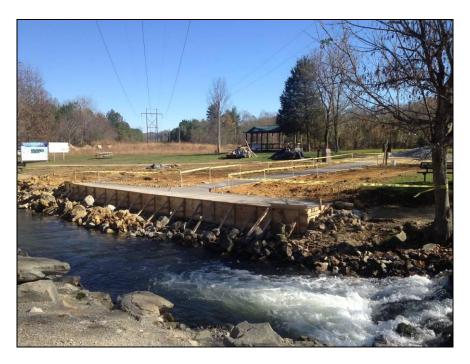
Public Fishing Area: Sidewalk after concrete was poured. (Picture taken from LDB at ~Sta. 102+00 looking downstream).

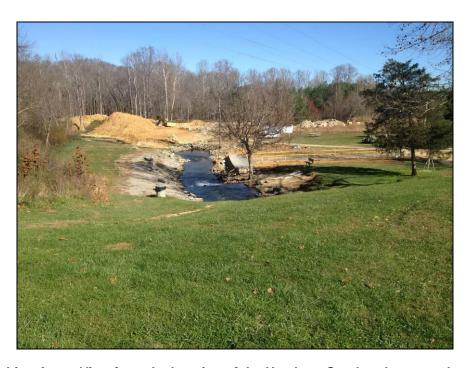
Public Fishing Area: View from the location of the Hatchery Creek web cam at the end of the week. Web address of web cam is: http://wcnfh.com/cam0.php
